**Flood Control Project Maintenance  
Levee Inspections**

## Maintenance Issue Types Only, Levee Inspection Report By Mile - Spring 2019

### Sutter Maintenance Yard Maintenance Area 0017

Waterway	Bank	Unit Miles	Inspection Start/End	Inspector
Unit No. 01 Lake County Sutter Maintenance Yard - Middle Creek	Left	3.87	04/04/2019 04/04/2019	Luz Dial

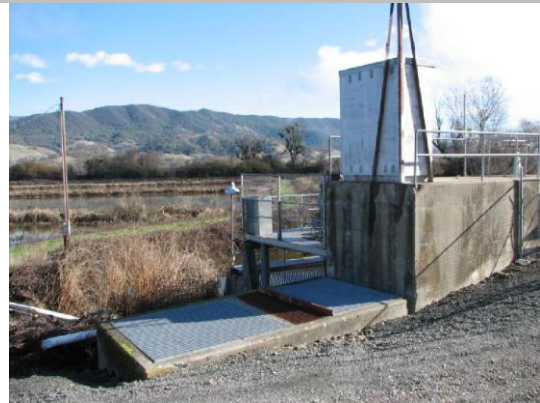
Photo 1 of 3 : UCIP\_SP\_2019\_50815\_46853.jpg

Comment Code					
Inspector Comment					
FS_ID:50815 DS_ID:845 EP_NO: 11464 Repair Type: No Action Needed Crossing Status: Found UCIP Comments: 10/27/2017 This structure is inspected annually under the Structure and Channel Summer Inspection (part of the Levee Inspection Program) conducted by the DWR Flood Project Integrity and Inspection Branch (FPIIB). (DWR UCIP - O. Magana) 10/19/2016 Crossing appears to be in good condition. (DWR Sutter Yard- A Freitag)6/14/2016 crossing appears to be in goiid condition.4/23/2015 No issues with pipe.7/3/2014 Same as last inspection.12/23/2013 Same as last inspection.8/2/2013 Same as last inspection. FIELD_STRUCT_DESC: [Bloody Island Pumping Plant] 1 of 2: 42-inch corrugated metal drainage pipe through the levee, 20.2 feet below the crown. Concrete headwall and discharge apron on the waterside (WS) shoulder. Three vertical pump units mounted on a reinforced concrete pump platform in drainage ditch at the landside (LS) toe. Flap gates in concrete discharge well on the LS. Combination flap and slide gate on a gravity pipe from drainage ditch into discharge well. (two 42-inch pipes [HLM 4.18] authorized under Automatic Board Order (ABO) issued as Permit No. 11464, 1975 - Lake County). [Additional Reference(s): DWR Levee Log, 2005. USACE Sacramento O&M Manual 506.2, August 1961, (HLM 4.18)]. FS Date: 11/21/2016 12:10:29 PM

Pumping Plant on LS shoulder.

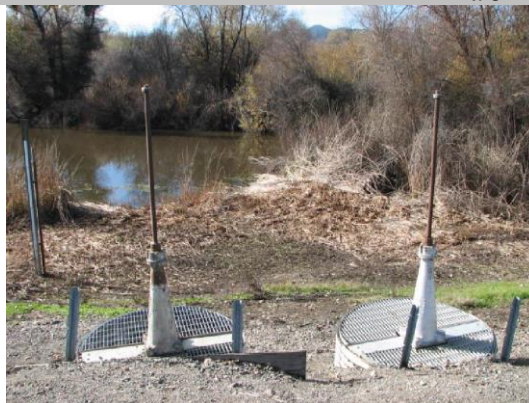
Photo 2 of 3 : UCIP\_SP\_2019\_50815\_46852.jpg

Comment Code						
Inspector Comment						
FS_ID:50815 DS_ID:845 EP_NO: 11464 Repair Type: No Action Needed Crossing Status: Found UCIP Comments: 10/27/2017 This structure is inspected annually under the Structure and Channel Summer Inspection (part of the Levee Inspection Program) conducted by the DWR Flood Project Integrity and Inspection Branch (FPIIB). (DWR UCIP - O. Magana) 10/19/2016 Crossing appears to be in good condition. (DWR Sutter Yard- A Freitag)6/14/2016 crossing appears to be in goiid condition.4/23/2015 No issues with pipe.7/3/2014 Same as last inspection.12/23/2013 Same as last inspection.8/2/2013 Same as last inspection. FIELD_STRUCT_DESC: [Bloody Island Pumping Plant] 1 of 2: 42-inch corrugated metal drainage pipe through the levee, 20.2 feet below the crown. Concrete headwall and discharge apron on the waterside (WS) shoulder. Three vertical pump units mounted on a reinforced concrete pump platform in drainage ditch at the landside (LS) toe. Flap gates in concrete discharge well on the LS. Combination flap and slide gate on a gravity pipe from drainage ditch into discharge well. (two 42-inch pipes [HLM 4.18] authorized under Automatic Board Order (ABO) issued as Permit No. 11464, 1975 - Lake County). [Additional Reference(s): DWR Levee Log, 2005. USACE Sacramento O&M Manual 506.2, August 1961, (HLM 4.18)]. FS Date: 11/21/2016 12:10:29 PM

Slide gates in CMP risers on WS shoulder.

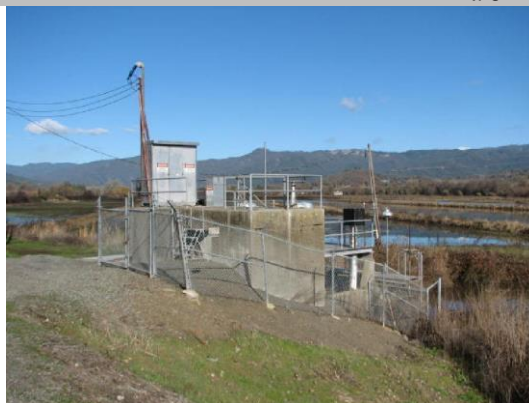
Photo 3 of 3 : UCIP\_SP\_2019\_50815\_46851.jpg

Pumping Plant on LS shoulder.

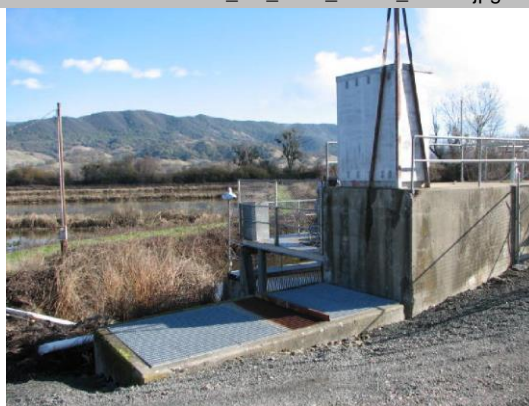
Photo 1 of 3 : UCIP\_SP\_2019\_50816\_46856.jpg

Comment Code						
Inspector Comment						
FS_ID:50816 DS_ID:852 EP_NO: 11464 Repair Type: No Action Needed Crossing Status: Found UCIP Comments: 10/27/2017 This structure is inspected annually under the Structure and Channel Summer Inspection (part of the Levee Inspection Program) conducted by the DWR Flood Project Integrity and Inspection Branch (FPIIB). (DWR UCIP - O. Magana) 10/19/2016 Crossing appears to be in good condition. (DWR Sutter Yard- A Freitag)6/14/2016 crossing appears to be in goioid condition.4/23/2015 No issues with pipe.7/3/2014 Same as last inspection.12/23/2013 Same as last inspection.8/2/2013 Same as last inspection. FIELD_STRUCT_DESC: [Bloody Island Pumping Plant] 2 of 2: 42-inch corrugated metal drainage pipe through the levee, 14.6 feet below the crown. Concrete headwall and discharge apron on the waterside (WS) shoulder. Three vertical pump units mounted on a reinforced concrete pump platform in drainage ditch at the landside (LS) toe. Flap gates in concrete discharge well on the LS. Combination flap and slide gate on a gravity pipe from drainage ditch into discharge well. (two 42-inch pipes [HLM 4.18] authorized under Automatic Board Order (ABO) issued as Permit No. 11464, 1975 - Lake County). [Additional Reference(s): DWR Levee Log, 2005. USACE Sacramento O&M Manual 506.2, August 1961, (HLM 4.18)]. FS Date: 11/21/2016 12:11:01 PM

Pumping plant on LS shoulder.

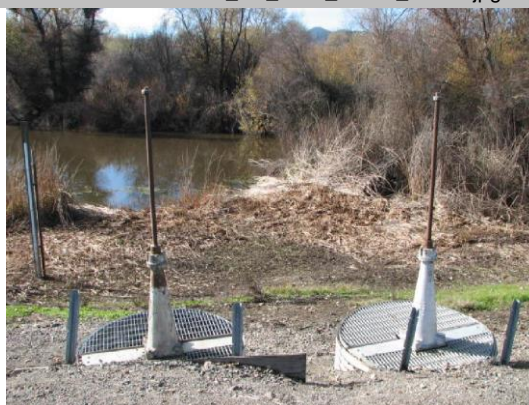
Photo 2 of 3 : UCIP\_SP\_2019\_50816\_46855.jpg

Slide gate in CMP riser on WS shoulder.

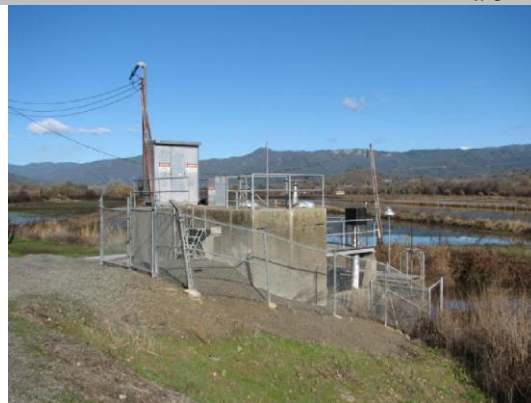
Photo 3 of 3 : UCIP\_SP\_2019\_50816\_46854.jpg

Comment Code						
Inspector Comment						
FS_ID:50816 DS_ID:852 EP_NO: 11464 Repair Type: No Action Needed Crossing Status: Found UCIP Comments: 10/27/2017 This structure is inspected annually under the Structure and Channel Summer Inspection (part of the Levee Inspection Program) conducted by the DWR Flood Project Integrity and Inspection Branch (FPIIB). (DWR UCIP - O. Magana) 10/19/2016 Crossing appears to be in good condition. (DWR Sutter Yard- A Freitag)6/14/2016 crossing appears to be in goioid condition.4/23/2015 No issues with pipe.7/3/2014 Same as last inspection.12/23/2013 Same as last inspection.8/2/2013 Same as last inspection. FIELD_STRUCT_DESC: [Bloody Island Pumping Plant] 2 of 2: 42-inch corrugated metal drainage pipe through the levee, 14.6 feet below the crown. Concrete headwall and discharge apron on the waterside (WS) shoulder. Three vertical pump units mounted on a reinforced concrete pump platform in drainage ditch at the landside (LS) toe. Flap gates in concrete discharge well on the LS. Combination flap and slide gate on a gravity pipe from drainage ditch into discharge well. (two 42-inch pipes [HLM 4.18] authorized under Automatic Board Order (ABO) issued as Permit No. 11464, 1975 - Lake County). [Additional Reference(s): DWR Levee Log, 2005. USACE Sacramento O&M Manual 506.2, August 1961, (HLM 4.18)]. FS Date: 11/21/2016 12:11:01 PM

Pumping plant on LS shoulder.

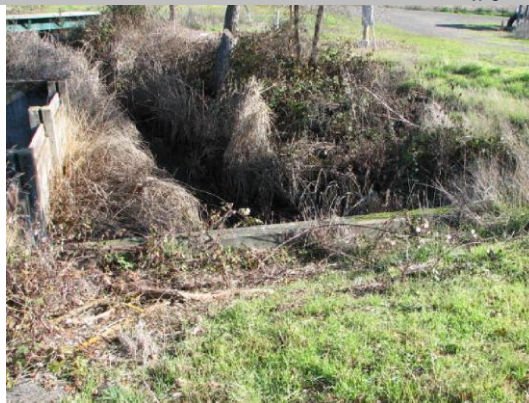
Photo 1 of 3 : UCIP\_SP\_2019\_50821\_46869.jpg

Comment Code					
Inspector Comment					
FS_ID:50821 DS_ID:849 EP_NO: 11467 Repair Type: No Action Needed Crossing Status: Found UCIP Comments: 10/27/2017 This structure is inspected annually under the Structure and Channel Summer Inspection (part of the Levee Inspection Program) conducted by the DWR Flood Project Integrity and Inspection Branch (FPIIB). (DWR UCIP - O. Magana) 10/19/2016 Crossing appears to be in good condition. (DWR Sutter Yard- A Freitag) 6/14/2016 Flap gate propped open. Will make sure its closed before flood season. 4/23/2015 Flap gate propped open. Not an issue at this time. Will close it before high water season. 7/3/2014 Same as last inspection 12/23/2013 Same as last inspection. 8/2/2013 Same as last inspection. FIELD_STRUCT_DESC: [Highland Canal Diversion Weir and Drainage] 1 of 2: 54-inch corrugated metal drainage pipe through the levee 11.5 feet below the crown. Highland Canal Diversion Weir and Drainage Structure on the landside (LS). Concrete headwall on both landside (LS) and waterside (WS) toe with flap gate on the WS toe. (two 42-inch pipes [HLM 6.05] authorized under Automatic Board Order (ABO) issued as Permit No. 11467, 1975 - Modglin). [Additional Reference(s): DWR Levee Log, 2005. USACE Sacramento O&M Manual 506.3, August 1961, (HLM 6.05)]. FS Date: 11/21/2016 12:13:32 PM

Concrete weir/dam and channel on LS toe.

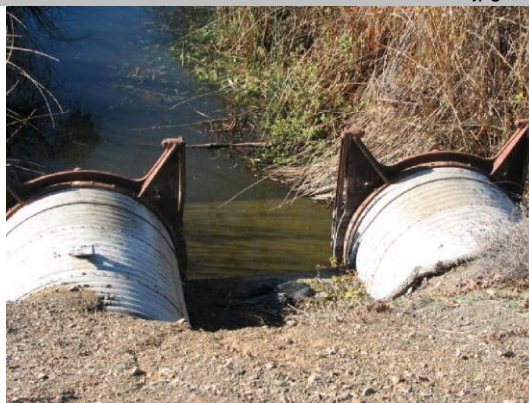
Photo 2 of 3 : UCIP\_SP\_2019\_50821\_46868.jpg

pipe and flap gate on WS toe.

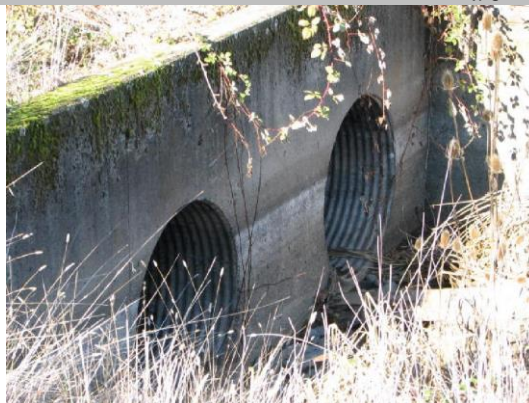
Photo 3 of 3 : UCIP\_SP\_2019\_50821\_46867.jpg

Comment Code						
Inspector Comment						
FS_ID:50821 DS_ID:849 EP_NO: 11467 Repair Type: No Action Needed Crossing Status: Found UCIP Comments: 10/27/2017 This structure is inspected annually under the Structure and Channel Summer Inspection (part of the Levee Inspection Program) conducted by the DWR Flood Project Integrity and Inspection Branch (FPIIB). (DWR UCIP - O. Magana) 10/19/2016 Crossing appears to be in good condition. (DWR Sutter Yard- A Freitag)6/14/2016 Flap gate propped open. Will make sure its closed before flood season.4/23/2015 Flap gate propped open. Not an issue at this time. Will close it before high water season.7/3/2014 Same as last inspection12/23/2013 Same as last inspection.8/2/2013 Same as last inspection. FIELD_STRUCT_DESC: [Highland Canal Diversion Weir and Drainage] 1 of 2: 54-inch corrugated metal drainage pipe through the levee 11.5 feet below the crown. Highland Canal Diversion Weir and Drainage Structure on the landside (LS). Concrete headwall on both landside (LS) and waterside (WS) toe with flap gate on the WS toe. (two 42-inch pipes [HLM 6.05] authorized under Automatic Board Order (ABO) issued as Permit No. 11467, 1975 - Modglin). [Additional Reference(s): DWR Levee Log, 2005. USACE Sacramento O&M Manual 506.3, August 1961, (HLM 6.05)]. FS Date: 11/21/2016 12:13:32 PM

Concrete headwall at inlet on LS toe.
